PROJECT MEMORANDUM
SCE WEST OF DEVERS UPGRADE PROJECT

Date: February 6, 2019
To: Billie Blanchard, Project Manager, CPUC
From: Vida Strong, Aspen Project Manager
Subject: Monitoring Report #48: January 20 to January 26, 2019

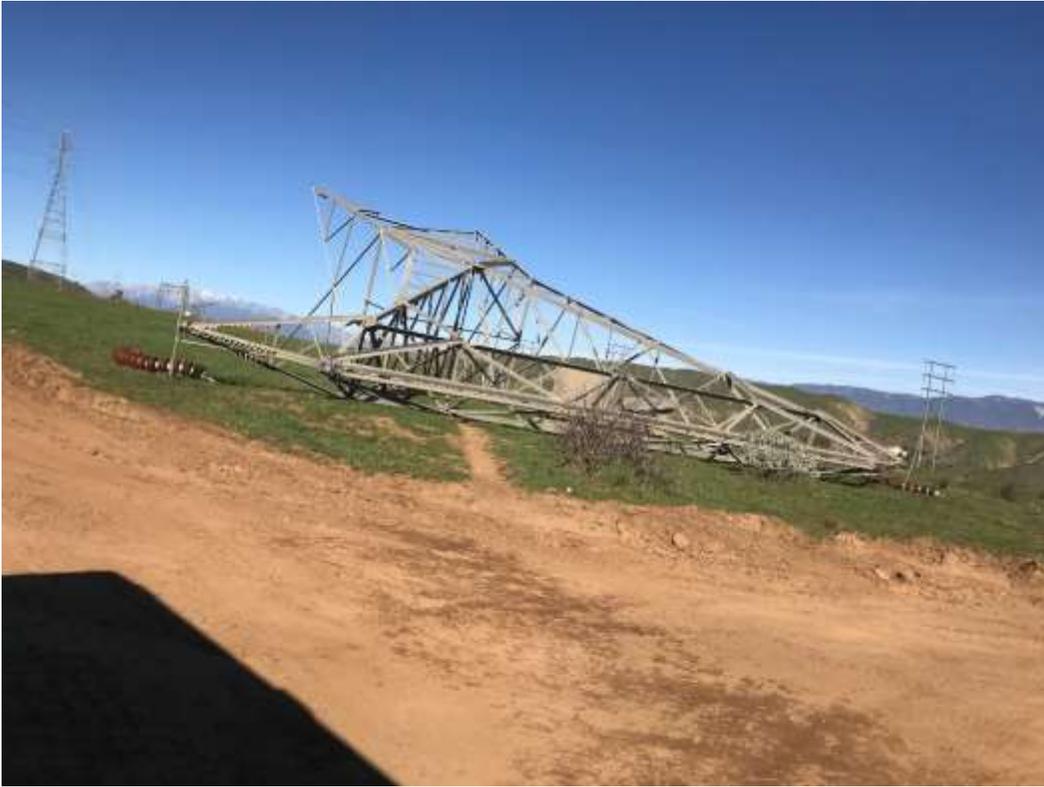
Photo 1 – Tower wreck-out activities near Tower 3X55, Segment 3.

4. Work associated with Segment 3 included access road maintenance; conductor removal between Sites 3X06 and 3X17; tower assembly between Sites 3X56 and 3X60; tower wreck-out between Sites 3X24 and 3X48, flying sockline between Sites 3X15 and 3X29, and 3X59 and 3X62; foundation work at sites between 3N03 and 3X06, and 3X55; and BMP installation/maintenance (see Photos 1-2).

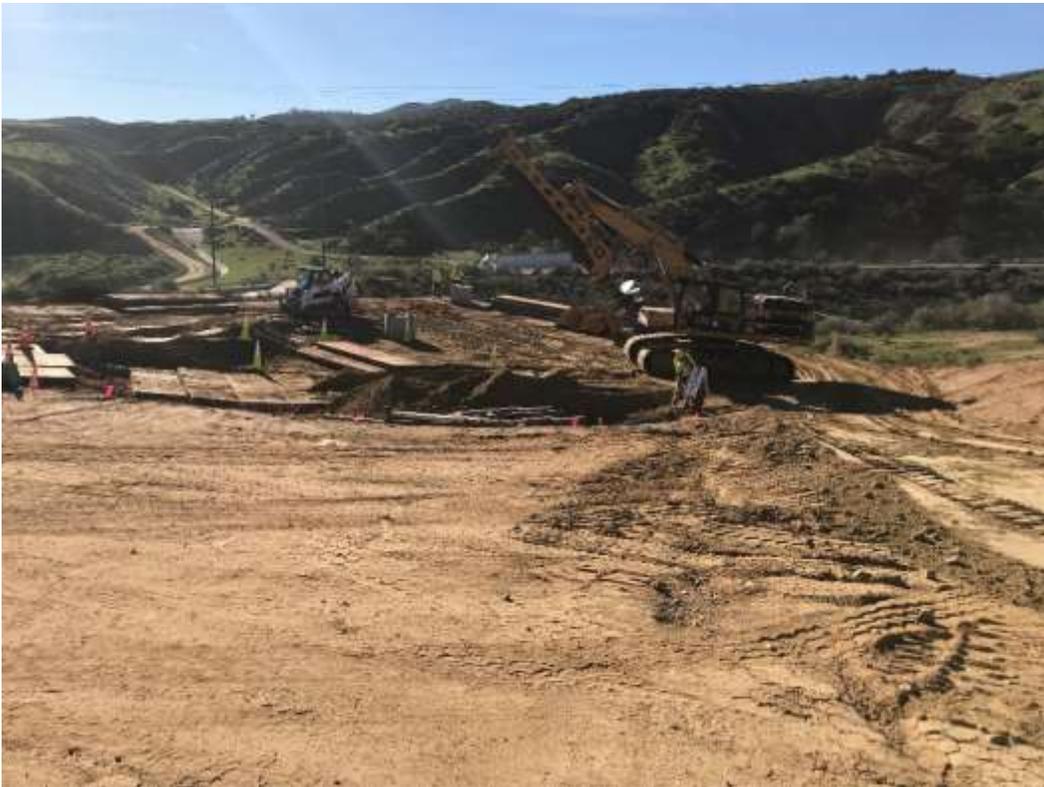
Photo 2 – Foundation excavation at Tower 3X55, Segment 3.
